## **Celebrating Our Woodland Heritage: Park Wood, Keighley An Archaeological Woodland Survey**

*Pennine Prospects  
Celebrating Our Woodland Heritage Project  
Report No: PP42/191219*

Report No: PP42/191219

December 2019

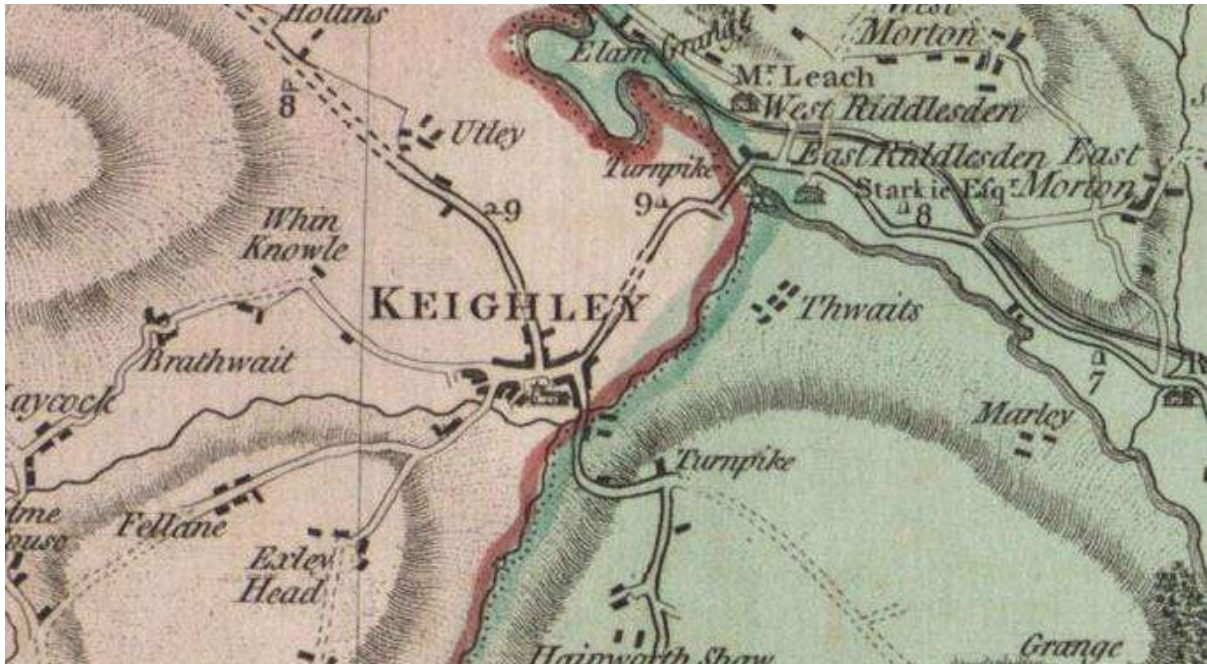
The County of York Survey by Thomas Jefferys (figure 3), published in 1772 is one of the first detailed surveys depicting the landscape and pattern of settlement (minus the pattern of field enclosure) around the study area. Although the woodland itself is not depicted, both the nucleated settlements of Keighley located to the west and Thwaits to the east of Park Wood are identifiable along with the River Worth; which marked the border between Skyrack Wapentake (to the east) and Staincliffe Wapentake (to the west).

Figure 3: Excerpt of the County of York Surveyed in (1772) MDCCLXVII, VIII, IX, and MDCCLXX Engraved by Thomas Jefferys (Sheet V). Park Wood would be found to the east of the settlement of Keighley and southwest of Thwaits. Copyright © The British Library Board, Source: <http://www.bl.uk/onlinegallery/onlineex/maps/uk/004966547uvu1771.html>

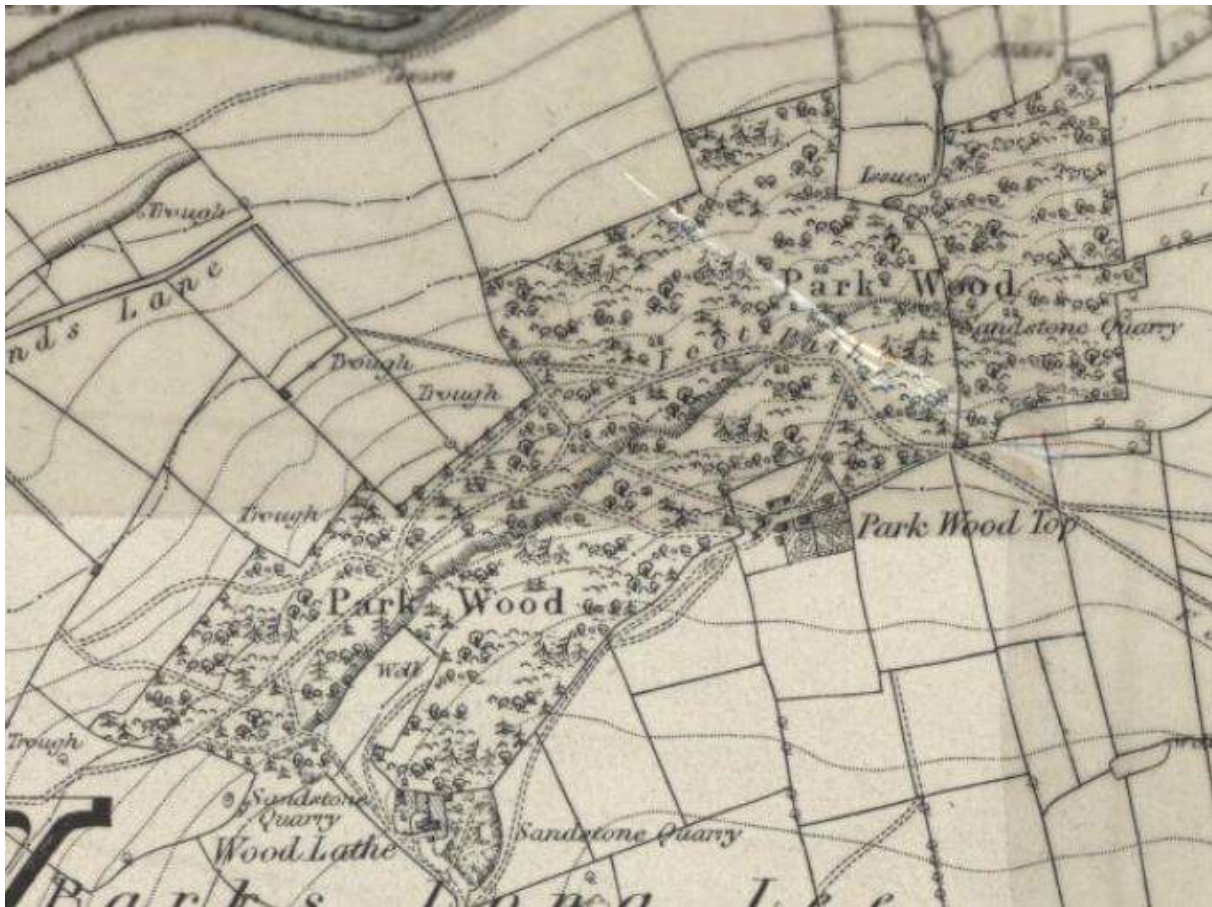
It is with the publication of the 1852 Ordnance Survey Six-Inch Survey (figure 4), that detail concerning the plan of Park Wood itself along with the pattern of landscape enclosure can be observed. The map shows the network of trackways that run through the wood as well as the site of two farmsteads, Park Wood Top along the southern edge of the woodland and Wood Lathe along its western edge.

Figure 4: Excerpt of the Yorkshire 200 (includes: Keighley.) OS Six-inch England and Wales surveyed between 1847 and 1848 and published in 1852. Copyright © National Library of Scotland, Source: <https://maps.nls.uk/view/102344905>

It is interesting to note on the 1852 publication (figure 4) the depiction a southwest to northeast orientated ridge or scarp within the woodland, a feature that was exploited after the production of this map for the extraction of millstone grit. By the time of the 1894 1:2500 First County Series Survey (figure 5) publication, the level of mineral extraction within the woodland is clear, with three large quarries (the western most labelled as 'Old Quarry') represented as cutting into the scarp mentioned above. In addition extraction had begun within the vicinity of Wood Lathe (now labelled as Park Wood Top). The network of tracks within the woodland at this date would suggest the material extracted from the quarries was being transported towards Keighley rather than Thwaites Brow.

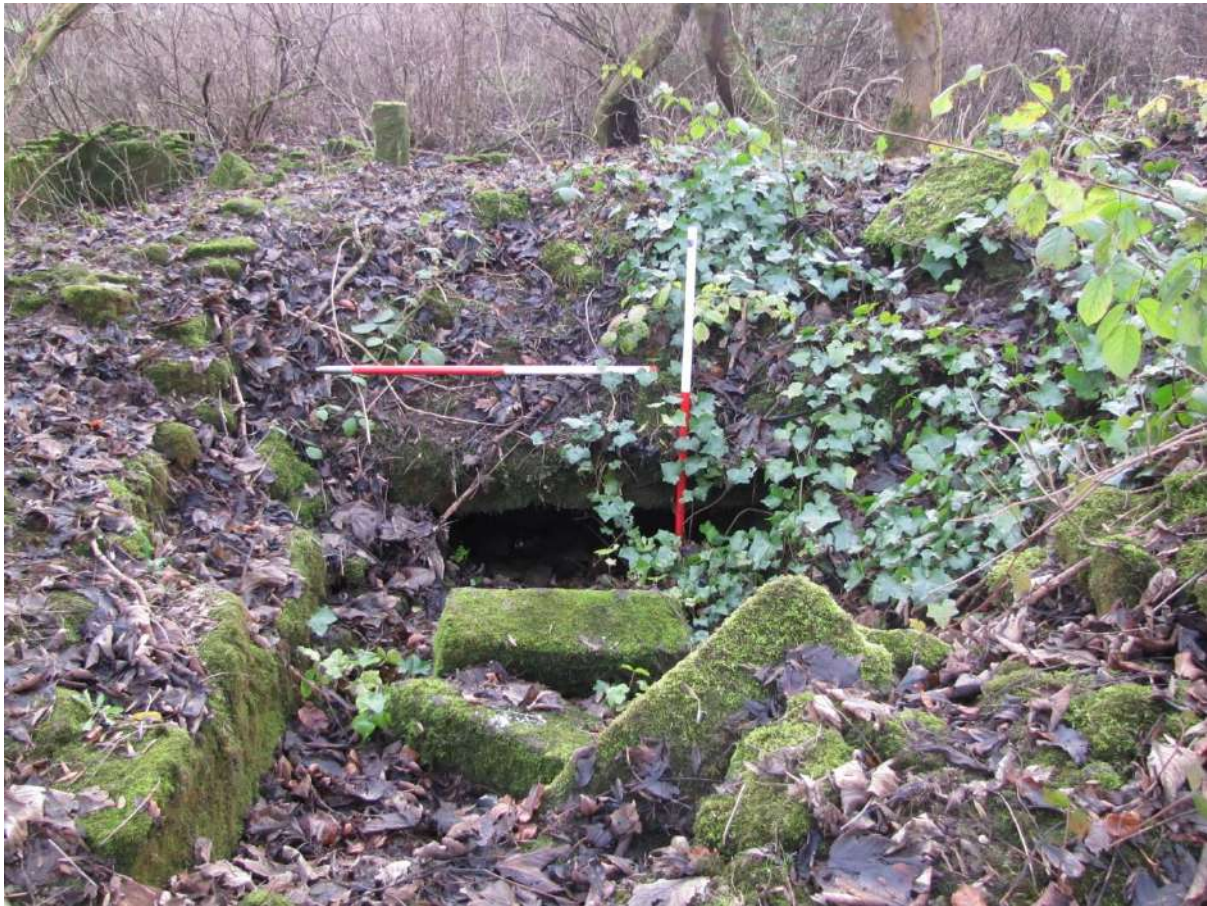
The remains of three structures (Site No. 22, 52, 53) were identified during the survey, all of which relate to the historic farmstead site of Park Wood Top located on the southern edge of the woodland. Sites 52 and 53 represent the foundation remains of two distinct two-storey structures located next to each other and accessed via a lane orientated northeast-southwest to the north. The eastern most structure (Site No. 53) is sunken at its centre, suggesting it once supported a cellar. The foundation remains at both sites stand no more than 1.50m tall. In addition individual thresholds which serve to mark divisions within each of the structures, as well as window ledges survive in places.

*Plate 1: Evidence of a cellar within the eastern most structure (Site No. 53) of Park Wood Top (Photograph: IMG\_7239; Scales are 1.0m). Copyright Pennine Prospects*

The condition of Park Wood Top (Site No 52 & 53) and its associated grounds (Site No. 20, 21, 22, 23, 24, 25, 26, 46, 47, 48, 49, 50 & 51) suggest a moderate to high degree of preservation concerning below ground archaeological features and deposits at each location. This is particularly important as the post-medieval farmstead and enclosure may have been established/utilised medieval foundations. As such scrub and sapling tree vegetation should be monitored and where necessary reduced upon the feature to reduce the risk of disturbance to below ground archaeological features and deposits. Young and mature trees upon or within the immediate vicinity should be coppiced/pollarded or felled in order to prevent windthrow damage. Any works at the site will likely require archaeological intervention.

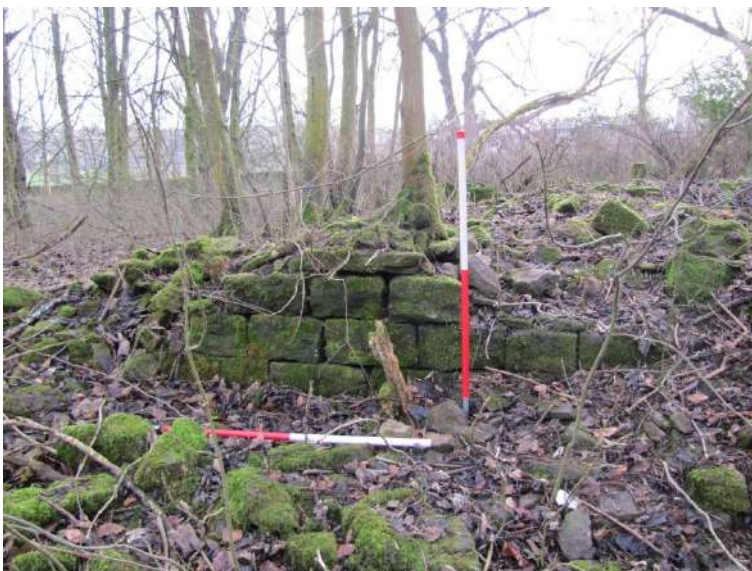
Each of the structures were constructed of dressed local millstone grit (plate 2) and brick. Evidence for the use of mortar and plaster can be found across the site.

*Plate 2: Surviving foundations of the eastern most structure (Site No. 53) of Park Wood Top (Photograph: IMG\_7241; Scales are 1.0m). Copyright Pennine Prospects*

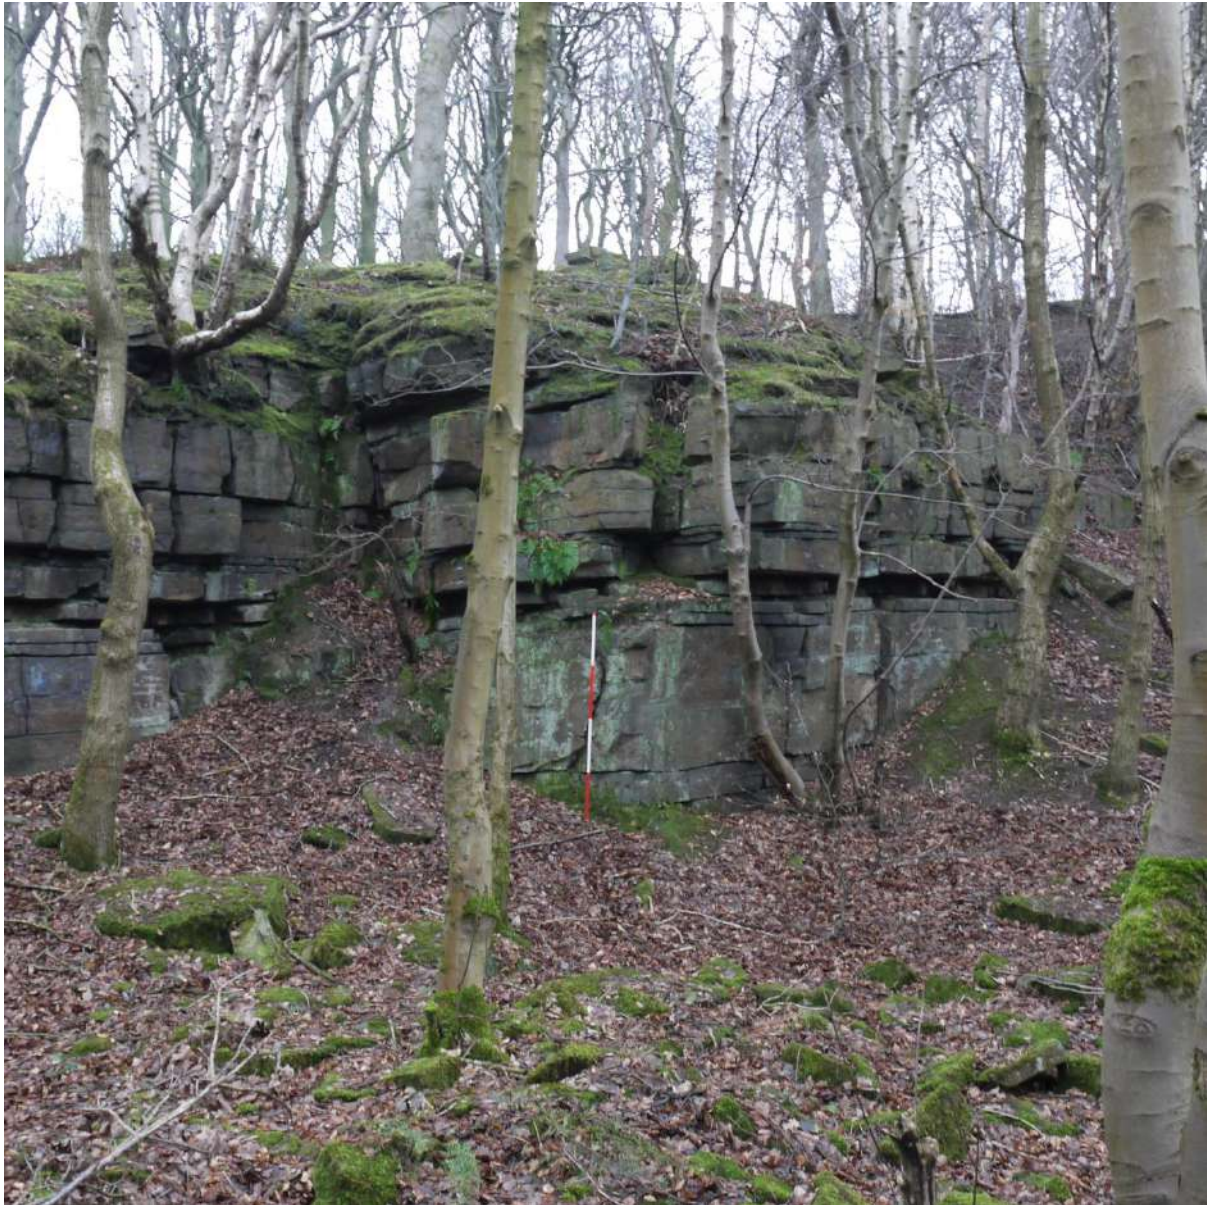
*Plate 3: Exposed millstone grit face within the western most quarry (Site No. 16) within Park Wood (Photograph: P1040217; Scale is 2.0m). Copyright Pennine Prospects*

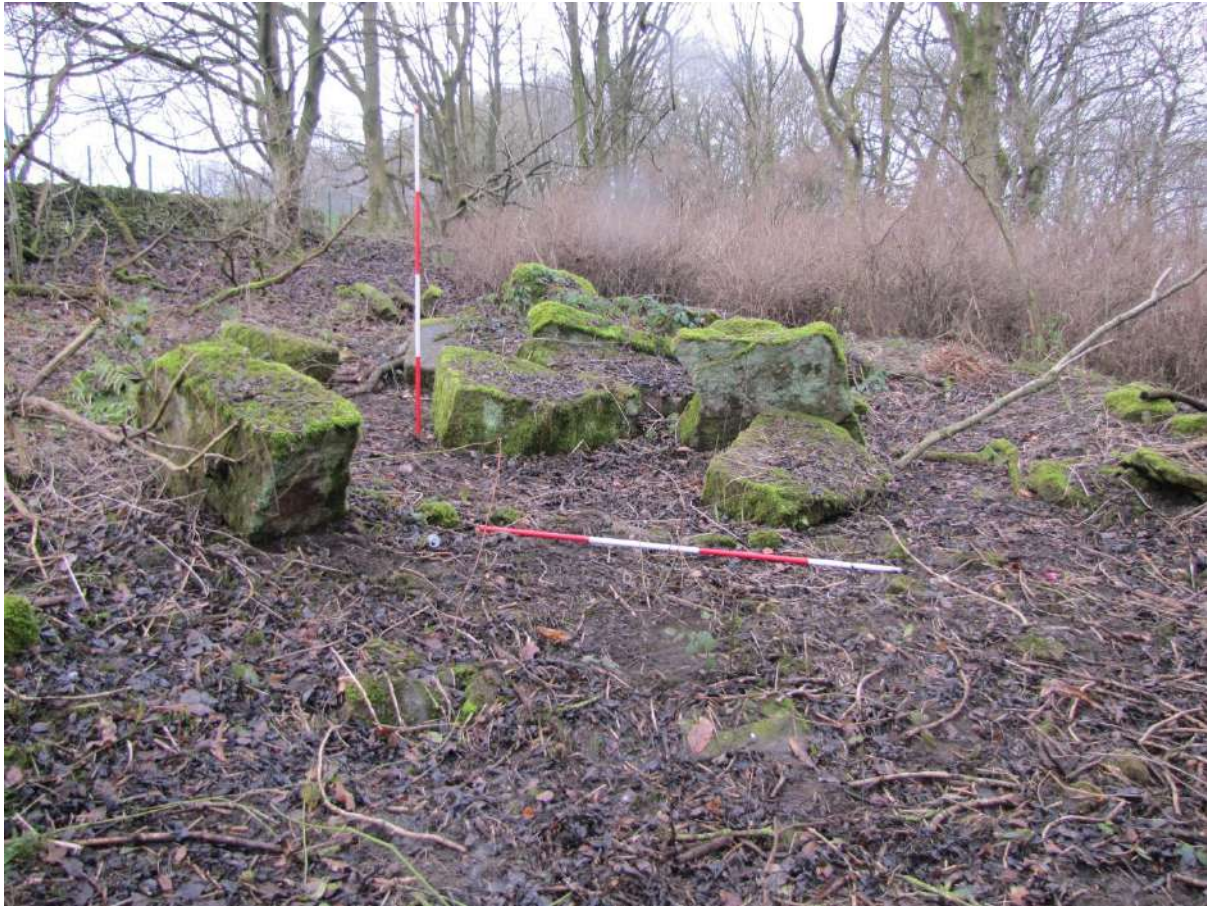
Located within the grounds of Park Wood Top, to the south of the site of the two buildings, is the site of a possible cairn or quarry stone processing area (Site No. 50; plate 4). The site covers an area of 12.50m diameter, and consists of a large pile of cut millstone grit angular blocks. One of the larger stone blocks measures up to 1.40m by 0.60m by 0.40m.

*Plate 4: Large cairn (Site No. 50) or site of a quarry processing area located to the south of Park Wood Top (Photograph: IMG\_7230; Scales are 2.0m). Copyright Pennine Prospects*

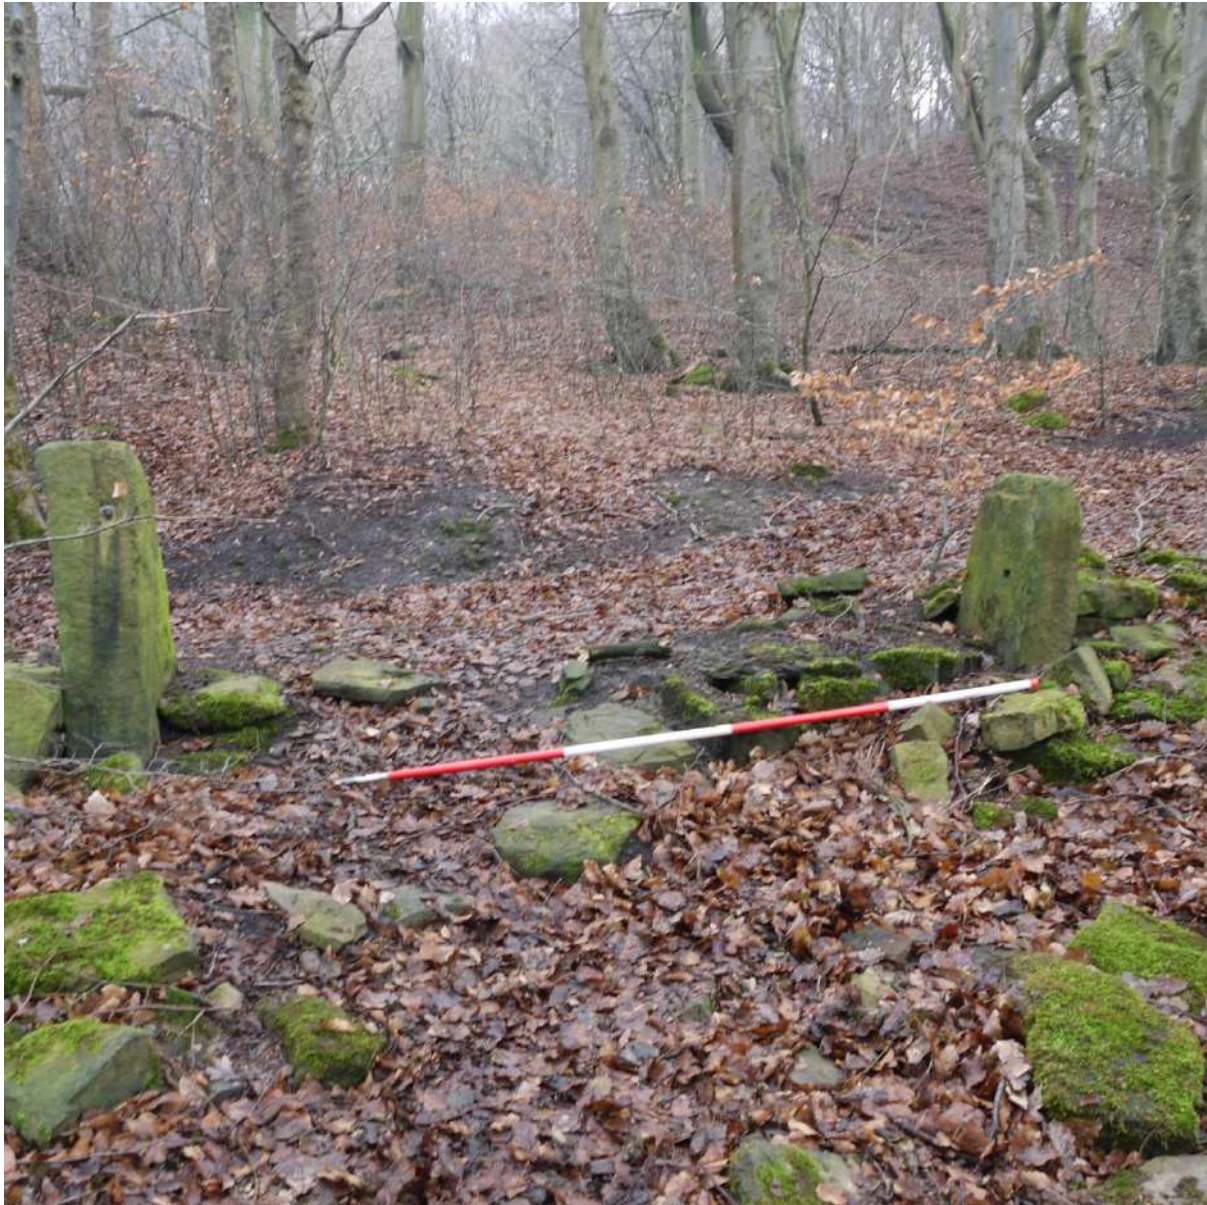
The boundaries here stand no more than 0.30m above the ground surface and on the whole survive as a line of partially exposed foundation stones. The site of two gated access ways is marked by gritstone posts along the relict boundary Site No. 5. One controlled access along the cobbled track (Site No. 1) and the other controlled

access to the site of a large gritstone quarry (Site No. 16) located to the south, via a terraced track (Site No. 4 & 14).

*Plate 5: Location of a gated access route (Site No. 5) through the site of a relict woodland boundary (Photograph: P1040192; Scale is 1.0m). Copyright Pennine Prospects*

All of the boundaries (with the exception of (Site No. 41 & 45) recorded during the survey are relict and in numerous states of decline. Each boundary should be monitored to ensure ground vegetation and tree saplings do not establish themselves on the stonework and cause damage/erosion. Mature trees within close proximity of all of the boundaries recorded during the survey should also be monitored and where appropriate, coppiced/pollarded, crowned, thinned or removed to prevent windthrow damage to the features. Although relict, the boundaries should be stabilised where necessary and maintained as relict features.

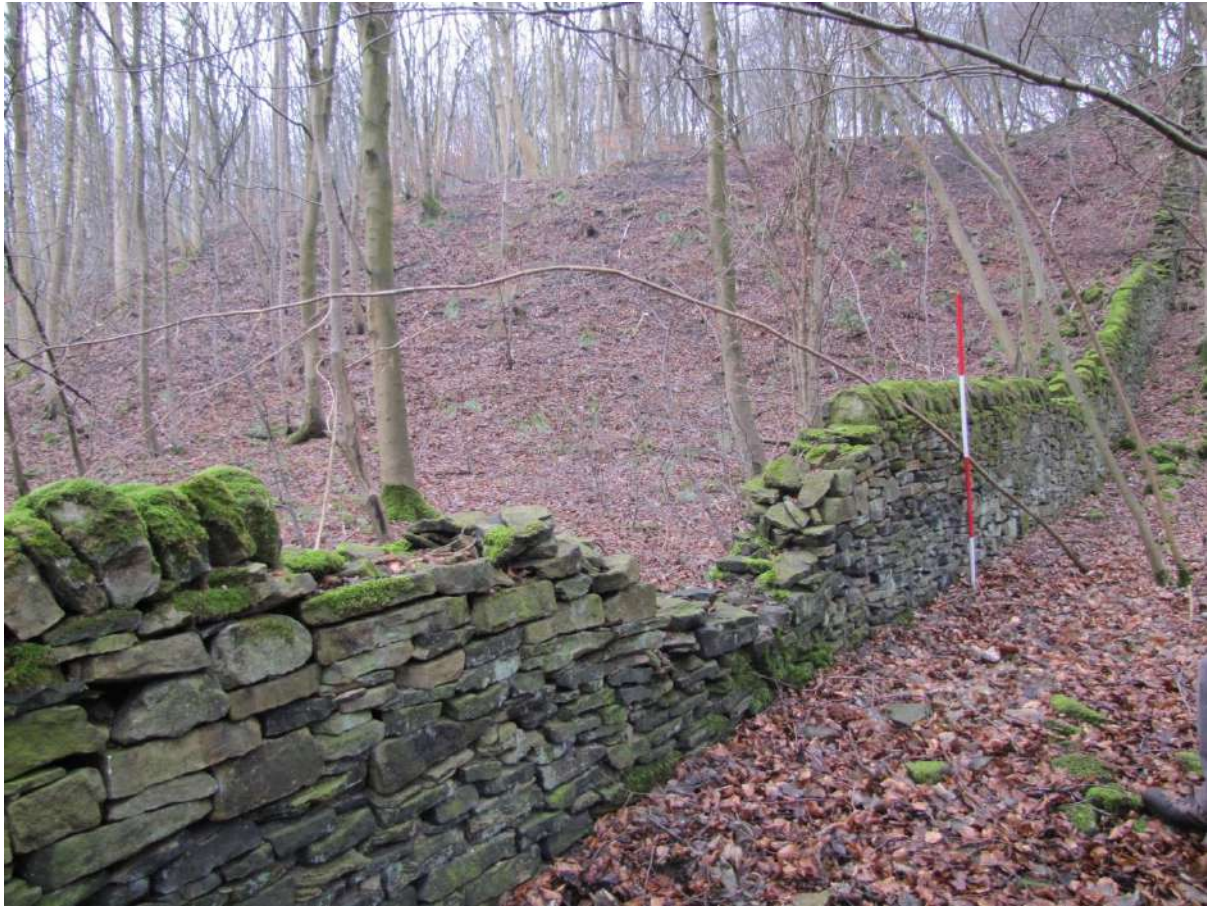
Where boundaries stand to their full height (Site No. 41 & 45; plate 6), they continue to serve as the woodland boundaries, separating park wood from Thwaites Brow to the south, or serving as a woodland compartment boundary. The irregular drystone walls stand to a height of 1.50m and up to 0.50m wide, supporting rounded coping stones.

*Plate 6: Woodland compartment boundary (Site No. 41) which separates the surveyed area of (Photograph: IMG\_7214; Scale is 2.0m). Copyright Pennine Prospects*

In the case of upstanding walls (Site No. 41 & 45) which serve to mark the southern edge of the woodland and the division between the privately owned woodland to the east; the boundary should be monitored to ensure ground vegetation and tree saplings do not establish themselves on the stonework and cause damage/erosion. Mature trees within close proximity of the boundaries should also be monitored and where appropriate, coppiced/pollarded, crowned, thinned or removed to prevent windthrow damage to the features. Any current damage along upstanding walls (such as the partial collapse of Site No. 41; plate 6) should be repaired.

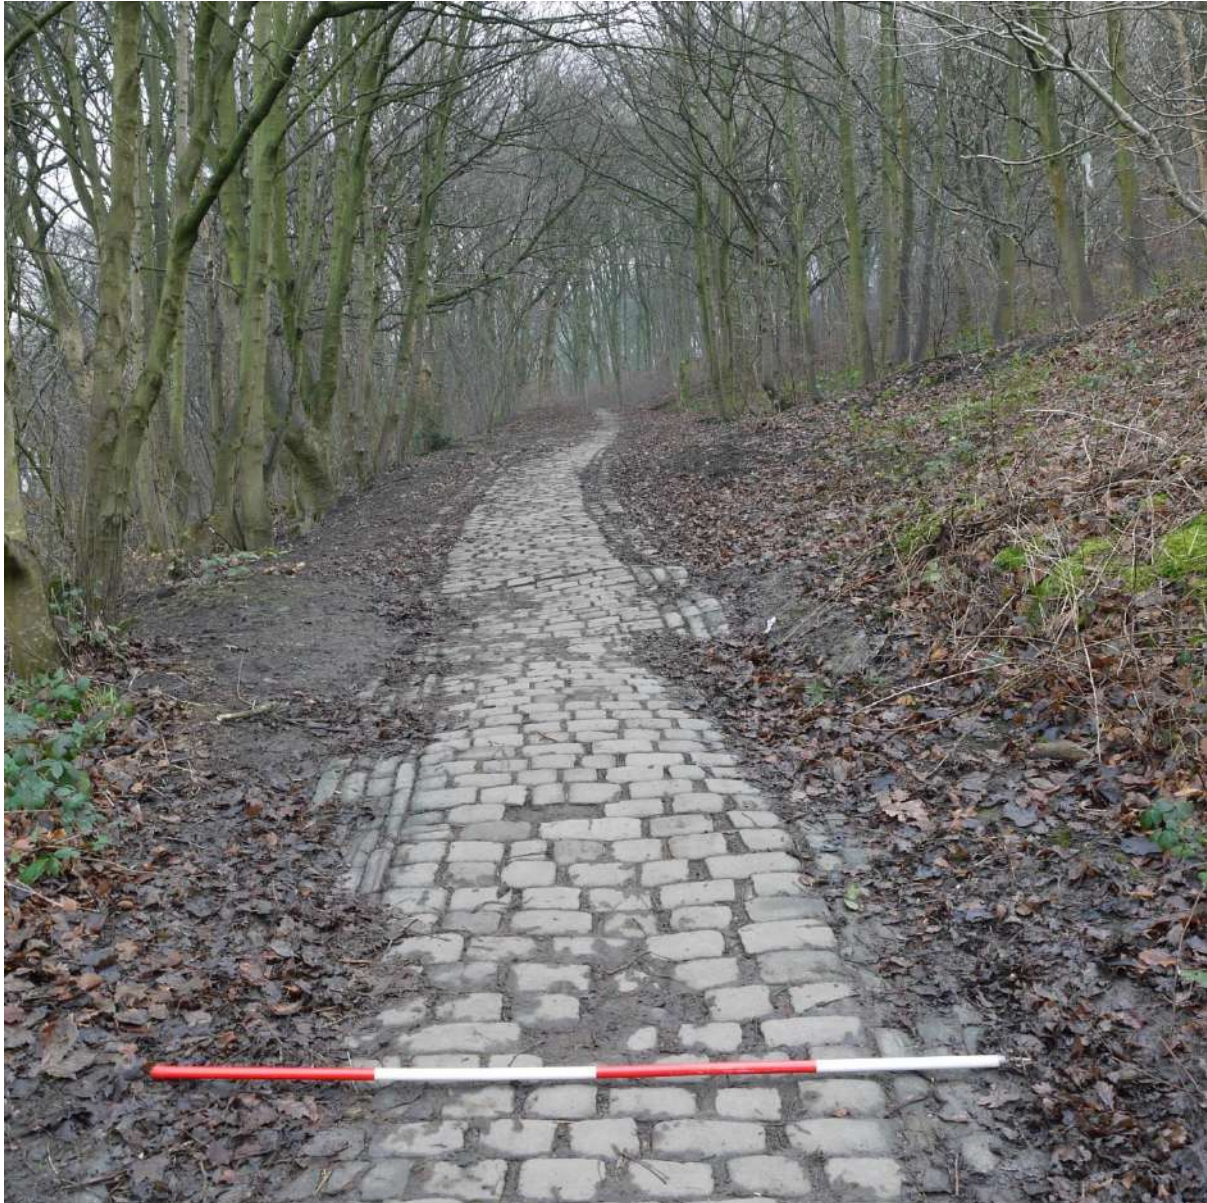
Elsewhere trackways consist predominantly of worn dirt terraced tracks. Where the trackways connect with areas of settlement (such as the site of Park Wood Top), trackways have been enhanced in order to establish a form a metalled surface. All of the trackways recorded during the survey provide access to sites of mineral

*Plate 7: Cobbled trackway (Site No. 1) which connects Kendal Street with Thwaites Brow via the mineral extraction area in Park Wood (Photograph: P1040187; Scale is 2.0m). Copyright Pennine Prospects*
